SSDA Pre-Northridge CONNECTION RETROFIT and/or UPGRADE Rationale
(U.S. Patent 10,697,192)

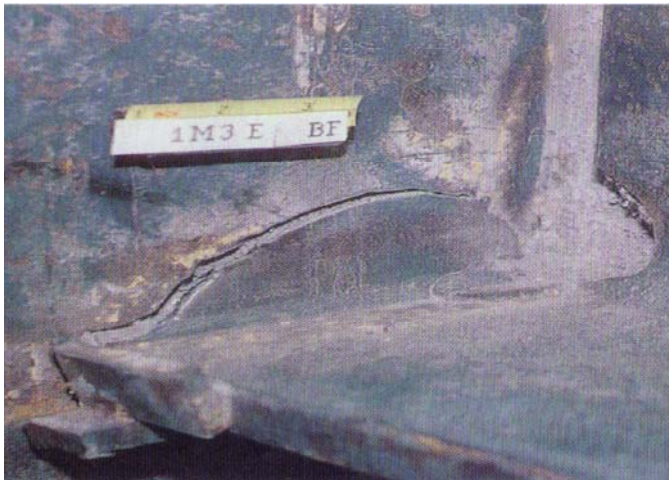
Pre-Northridge Connection Bottom Beam Flange Fracture – Column Flange Divot Pullout. This Fracture Mode is a Result of the Prying Action Due to the Shear in the Beam Flanges.

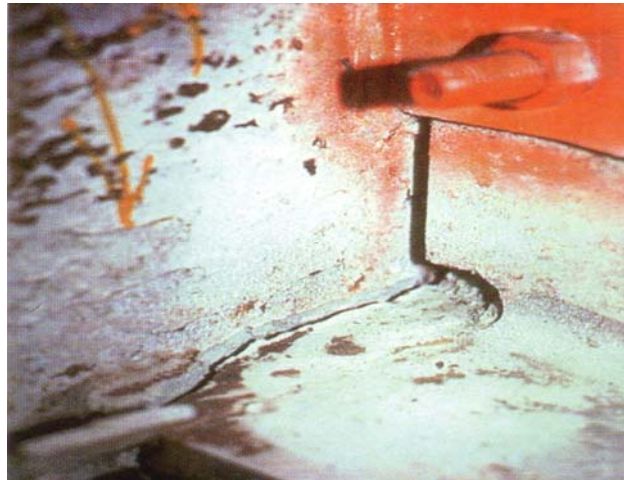
Pre-Northridge Connection - Bottom Beam Flange Weld Fracture. This Fracture Mode is a Result of Large Stress and Strain Gradients Across and Through the Beam Flanges and Welds.

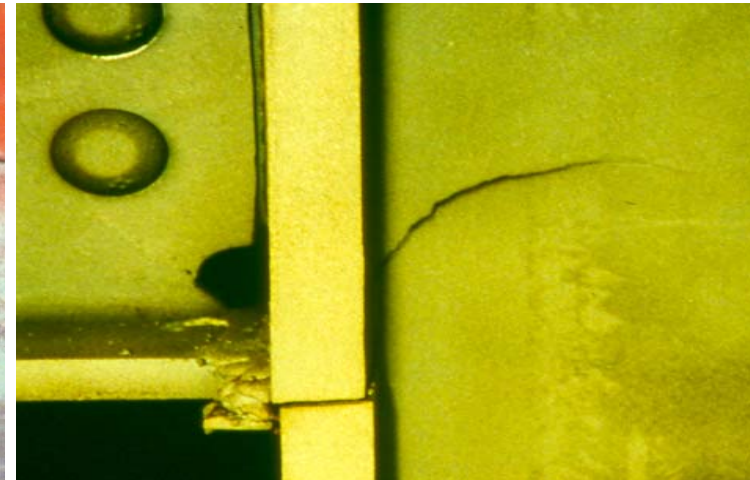
Pre-Northridge Connection Column Flange and Web Fracture Caused by Beam Flange Prying Action. Note the Absence of a Column Continuity Plate.

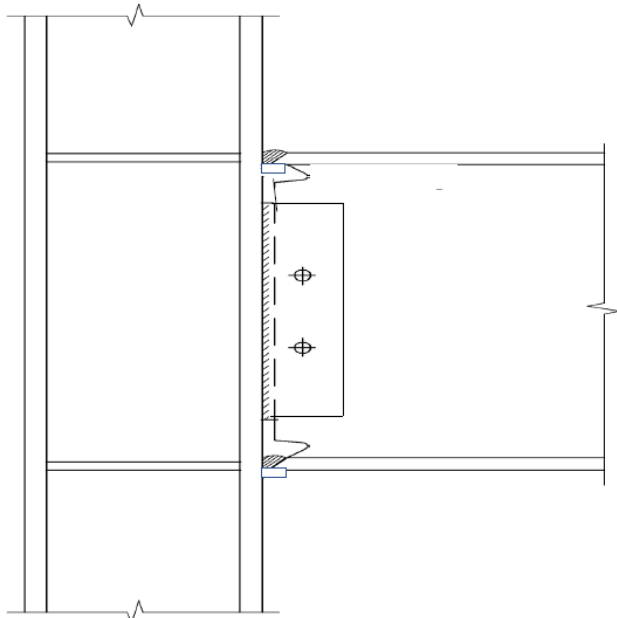
Pre-Northridge Connection (1970 -1994 – ref: FEMA 350)

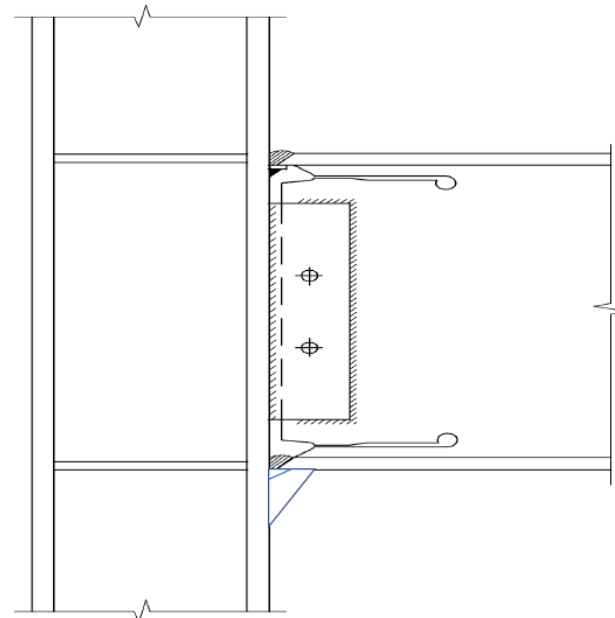
Retrofit Connection with Fins

- Weld the beam web to the column flange with a groove weld
- Fillet weld the shear plate to the beam web (TBD)
- Drill the stress relief holes in the beam web
- Thermal cut the beam web slots
- Fillet weld the top flange backup bar to the column flange
- Remove the bottom flange backup bar, back gauge and use a fillet weld to replace the gauged out backup plate weld
- Weld reinforcing fins to the bottom beam flange and to the column flange if required
