SSDA Pre-Northridge CONNECTION RETROFIT and/or UPGRADE Rationale
(U.S. Patent 10,697,192)

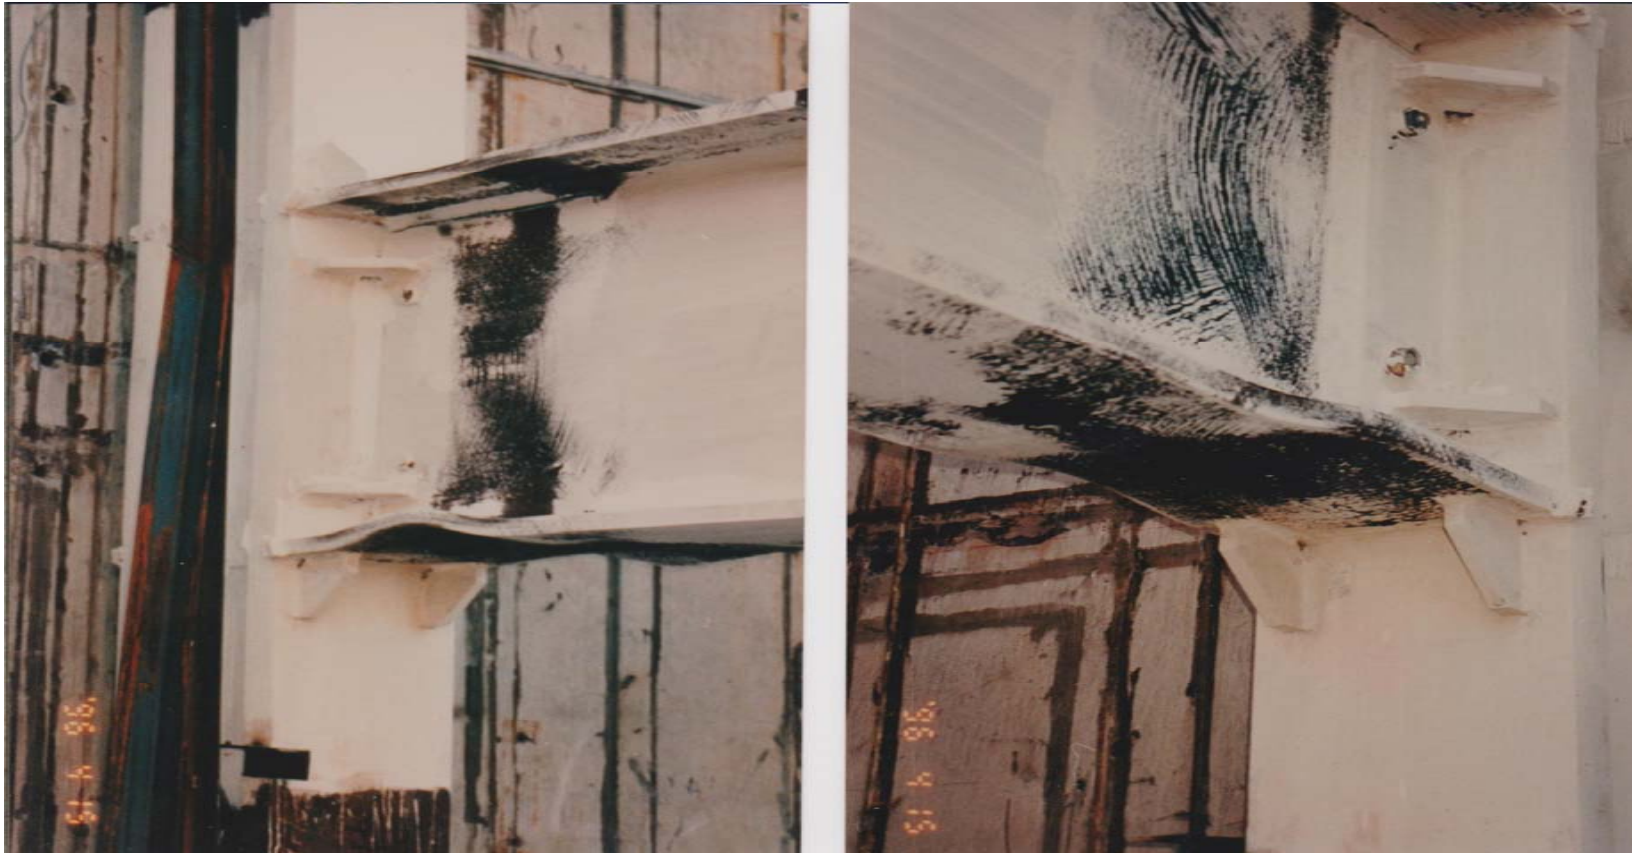
ATC-24 Test for Using a W36x170 Beam and a W14x283 Column

SSDA full scale retrofit test protocol demonstrating the use of fins to strengthen the beam flange welds and reduce the ductility demands on the existing welds.
